HD Technology Case Study:

Bearing monitoring of Paper Machine K25, Vrancart SA, Romania

SPM Instrument Bulgaria EOOD

August 2017

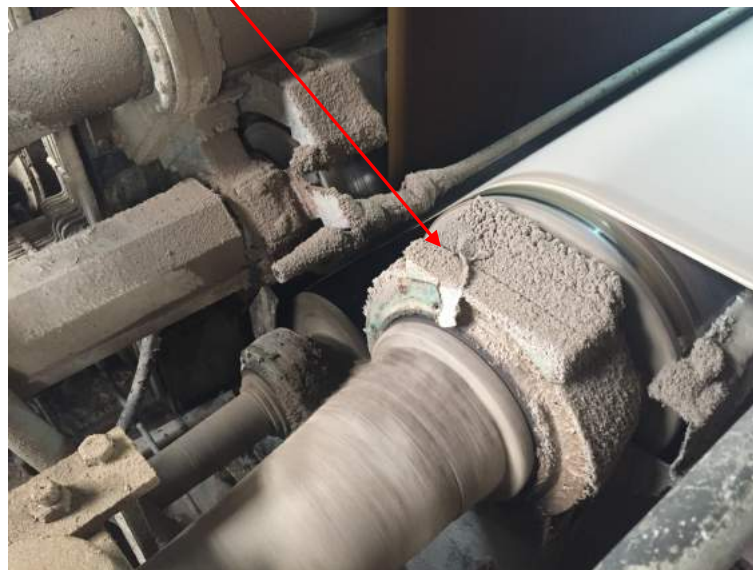
Image 1. Paper machine couch roll.

Couch roll bearing damage

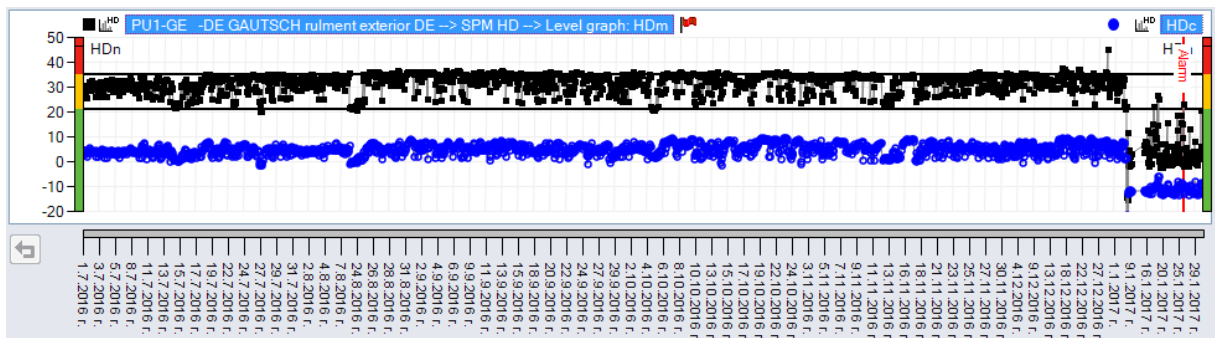
From the very beginning of the measurements on July 1st, 2016, right up until the time of bearing replacement on January 5th, 2017, HDm/HDc levels were continuously high; about 35 dB, which is on the alarm evaluation limit.

Fig 1. SPM HD trend graph HDm/HDc, from July, 2016, to February, 2017.

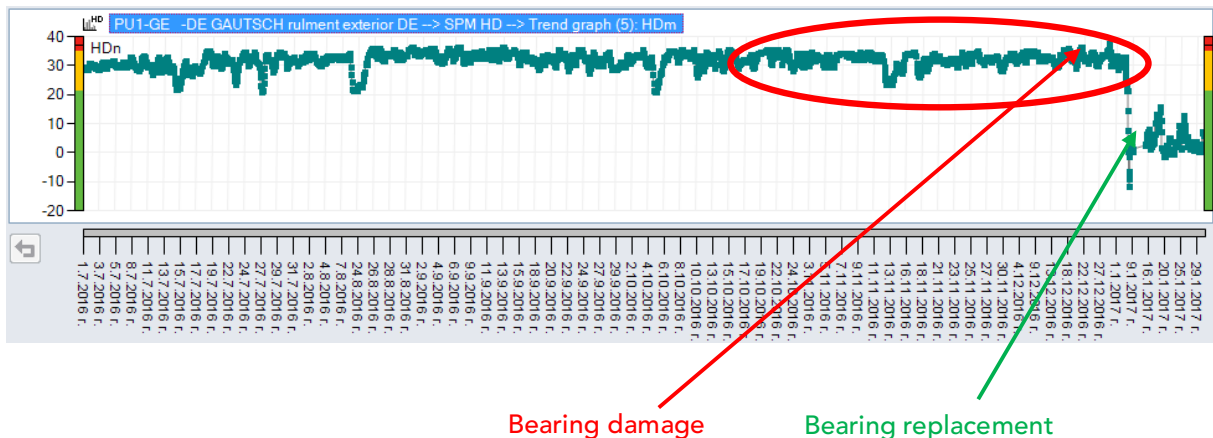
Fig 2. SPM HD averaged trend graph HDm (10 averages), from July, 2016 to February, 2017.

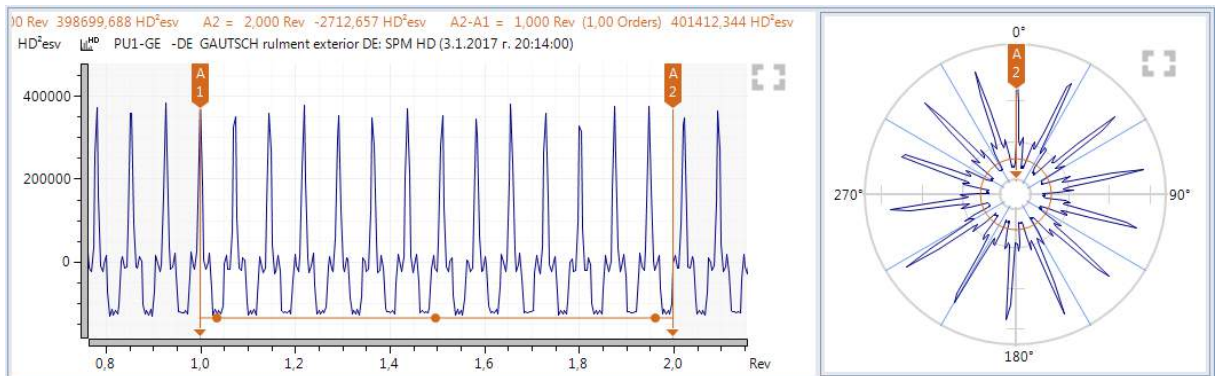
In the time signal, fourteen clear shocks per 1 revolution can be observed. In the spectrum, there are visible harmonics matching the BPFO bearing symptom for this 23096 FAG bearing.

Figure 3 shows a typical time signal for an outer race damage.

Fig 3. SPM HD Time signal and Circular plot diagram.

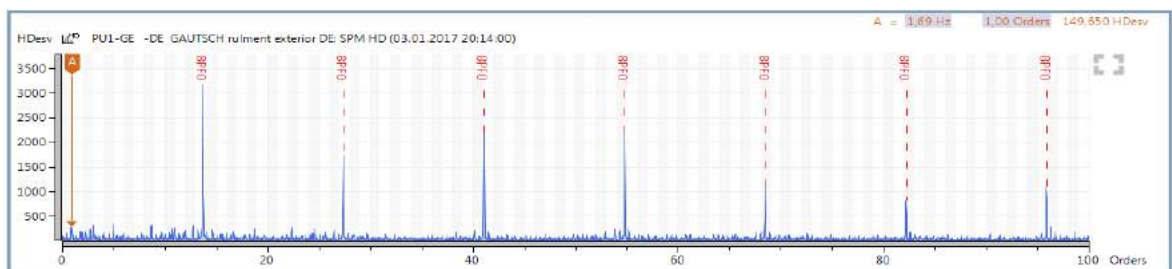
Very clear match of the BPFO symptom in the spectrum in Figure 4.

Fig 4. SPM HD Spectrum.

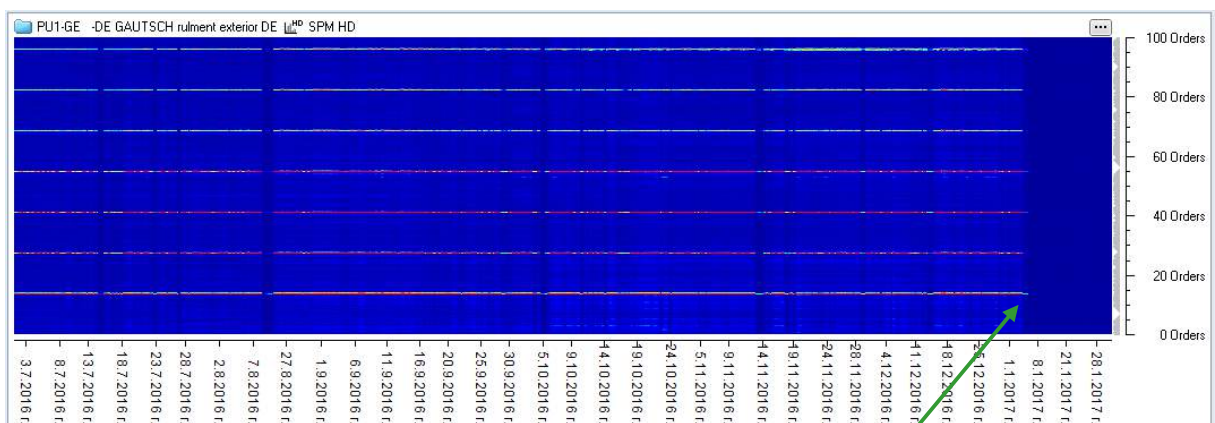
Fig 5. SPM HD Colored Spectrum Overview.

Bearing replacement

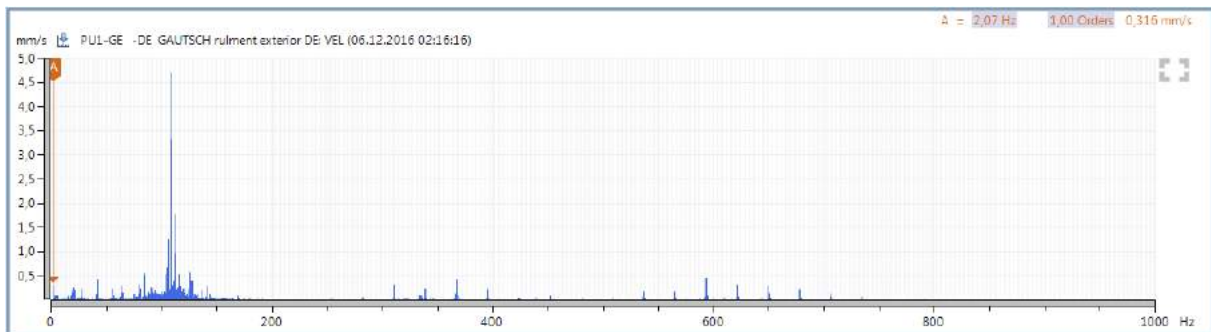
The signals just above 50X (see below) are related to the plastic seals of the vacuum chamber inside the roll. When the bearing was replaced, the seals were also replaced.

Fig 7. Velocity – VEL, Spectrum.

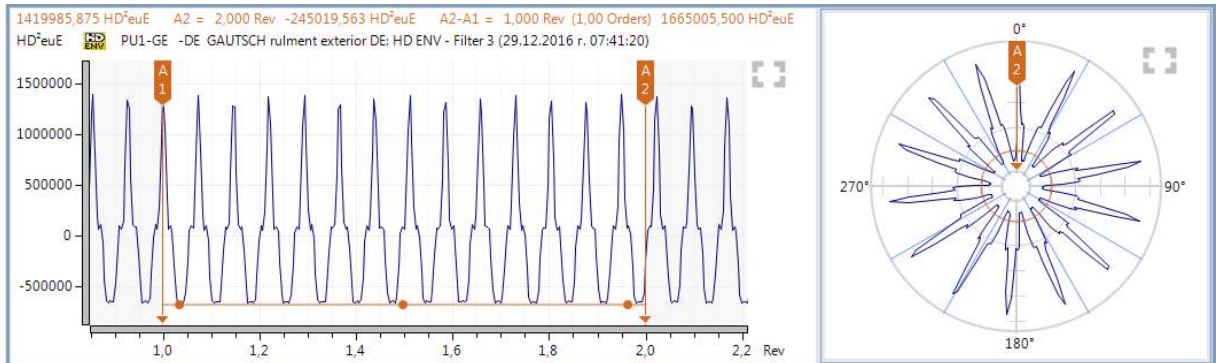
Figure 11 below shows a typical time signal for an outer race damage.

Fig 11. HD ENV - Filter 3, Time signal and Circular plot diagram.

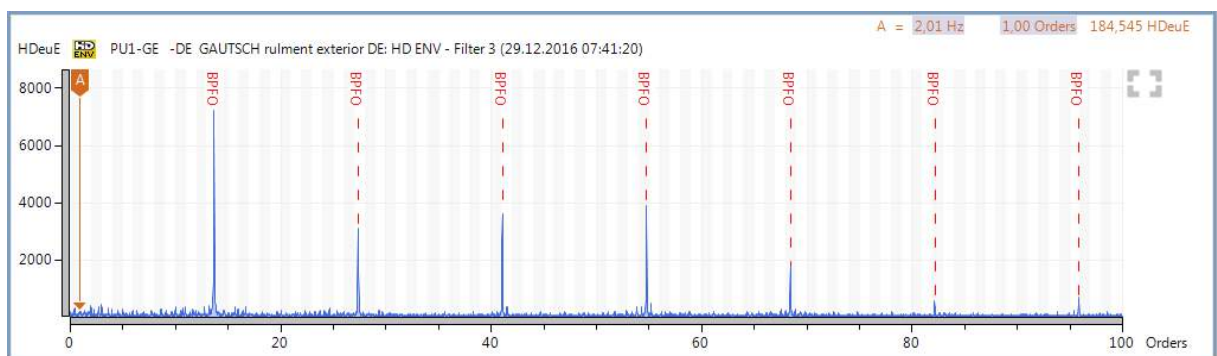
In Figure 12, a very clear BPFO match can be seen in the spectrum.

Fig 12. HD ENV - Filter 3, Spectrum.

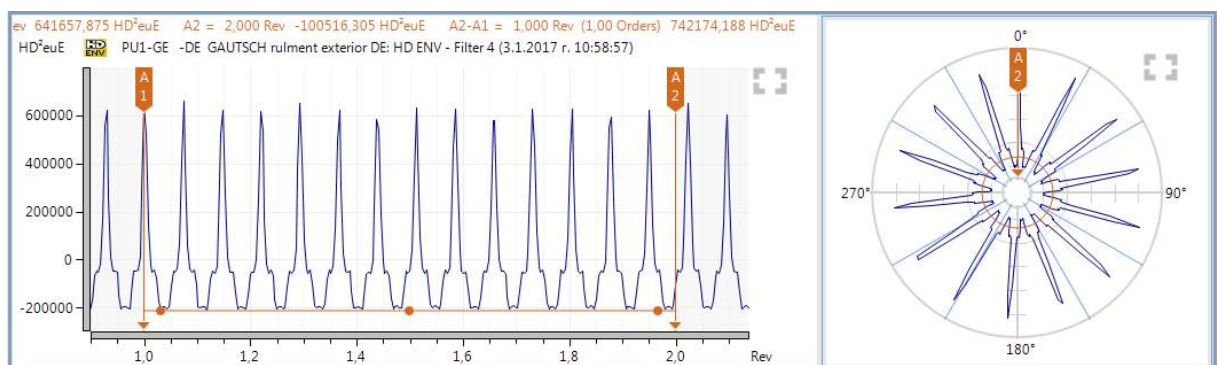
Figure 13 again shows a typical time signal of an outer race damage.

Fig 13. HD ENV - Filter 4, Time signal and Circular plot diagram.

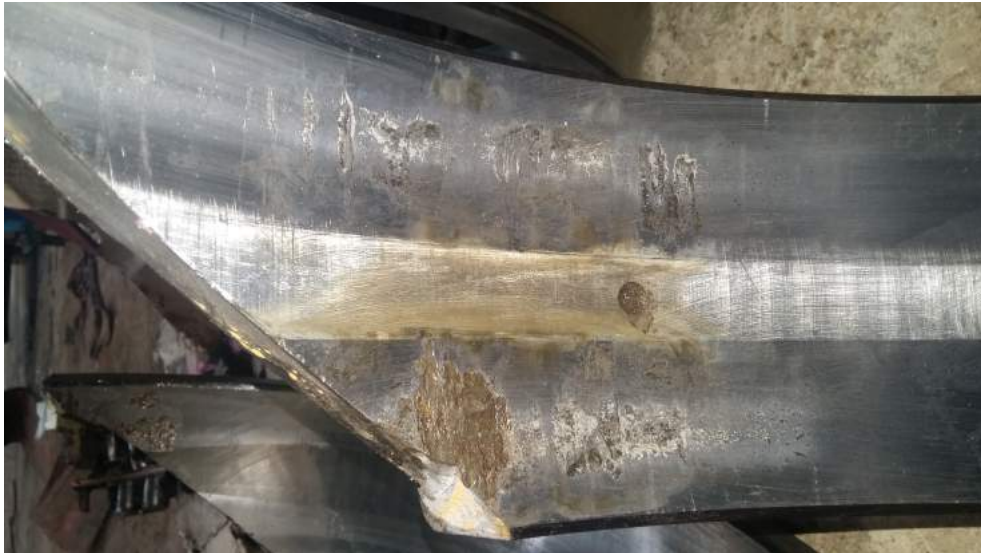
Below are photographs of the bearing after replacement. The outer ring was cut for easy dismantling. On it, the severe surface damage is visible.

Image 2. Damage to the bearing outer race.

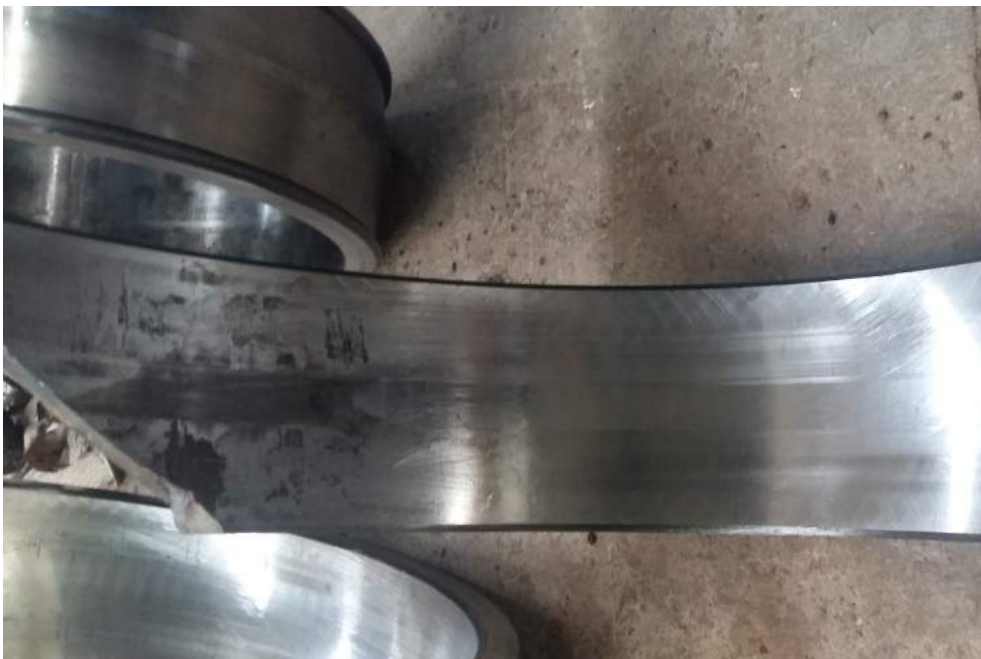
Image 3. Outer race bearing damage.

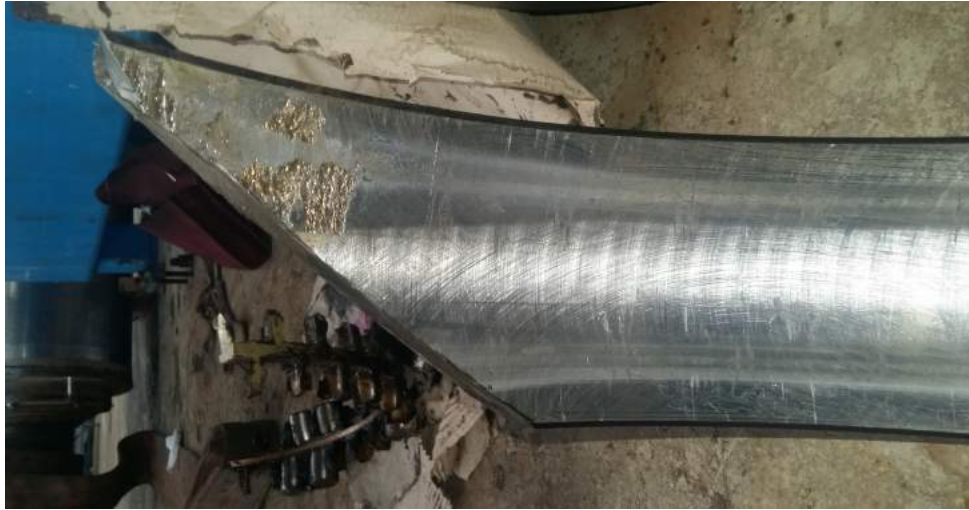
Image 4. Outer race damage.
