Multistage gearbox failure

Root cause analysis and recommendations for gearbox monitoring with HD technology

Göran Almqvist

SPM Instrument AB

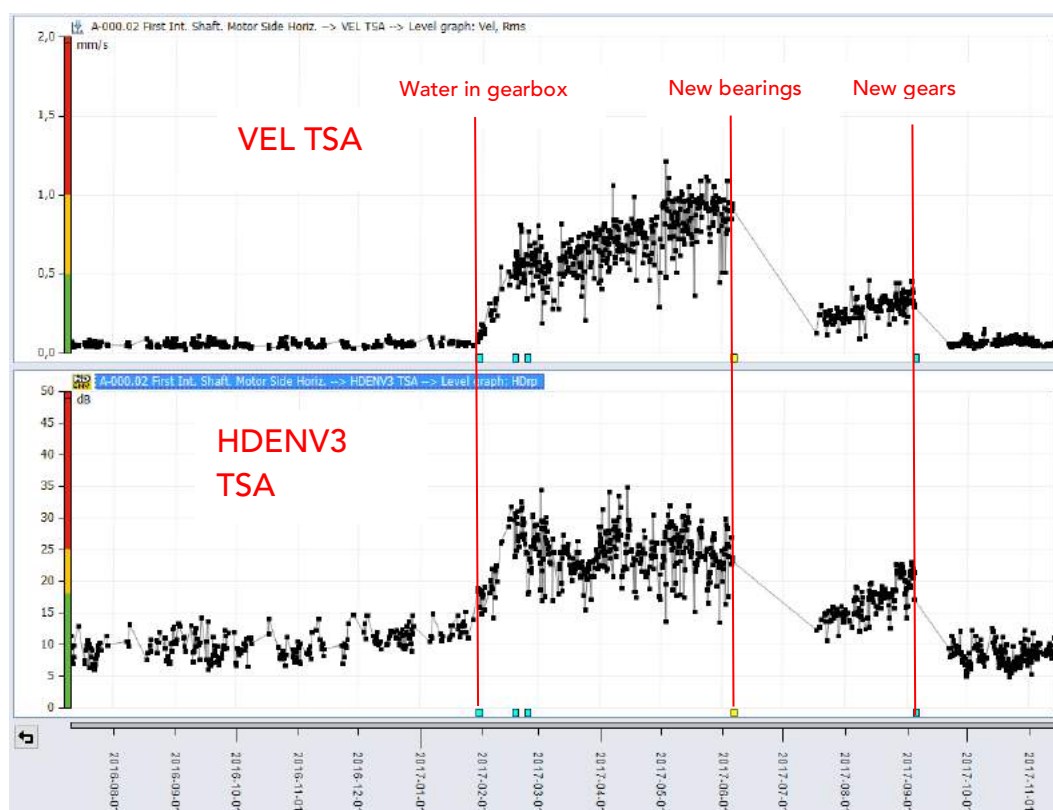
The amplitude of the measurements from the intermediate shaft showed a clear increase, mainly in the VEL TSA (Time Synchronous Averaging) measurements. Because TSA measurements only measure gear condition, this is a clear indication that there was a gear problem.

Fig. 9 Trend graphs of VEL TSA and HD ENV, Filter 3 TSA measurements.

The reason for the gear damage was poor lubrication. Unfortunately, the only measuring assignment for bearing measurements that was activated was HD ENV, Filter 3, and in those measurements, we could not see any bearing frequencies.

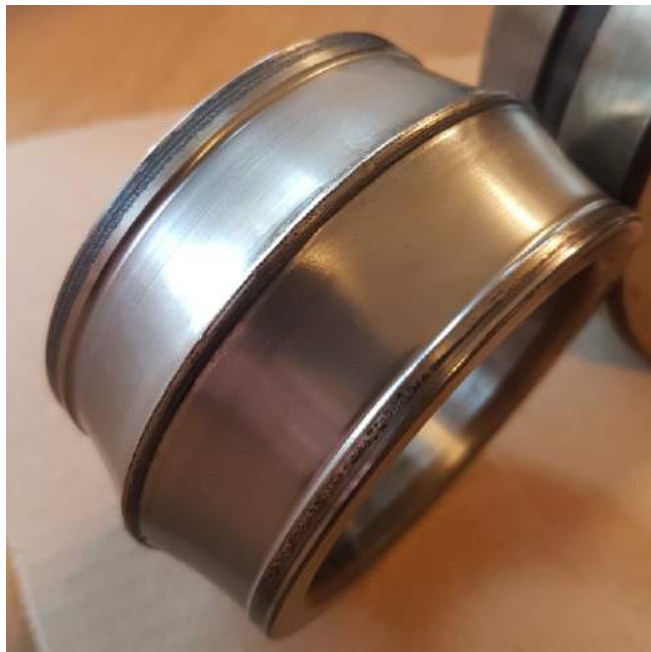
The bearing damage is quite interesting. There are no spalls in the bearing surface, but the surface is very worn, see Images 1 and 2:

Img. 1 Damaged bearing from the 1st intermediate shaft.

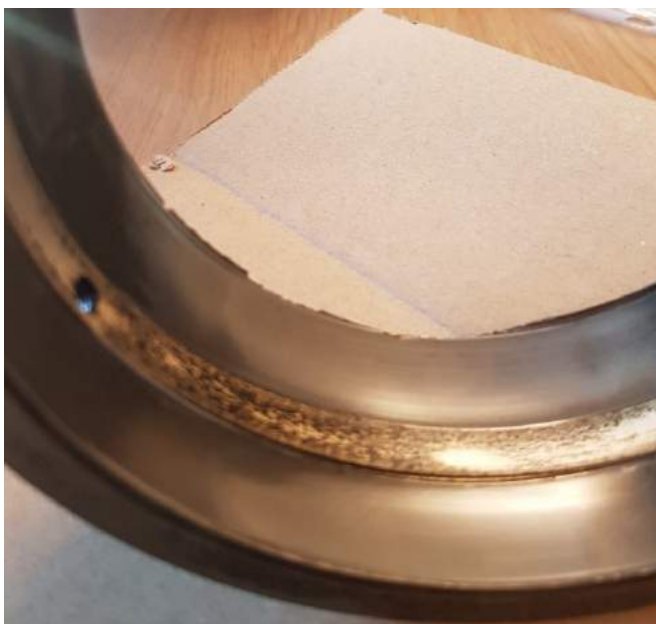
Img. 2 Damaged bearing from the 1st intermediate shaft.

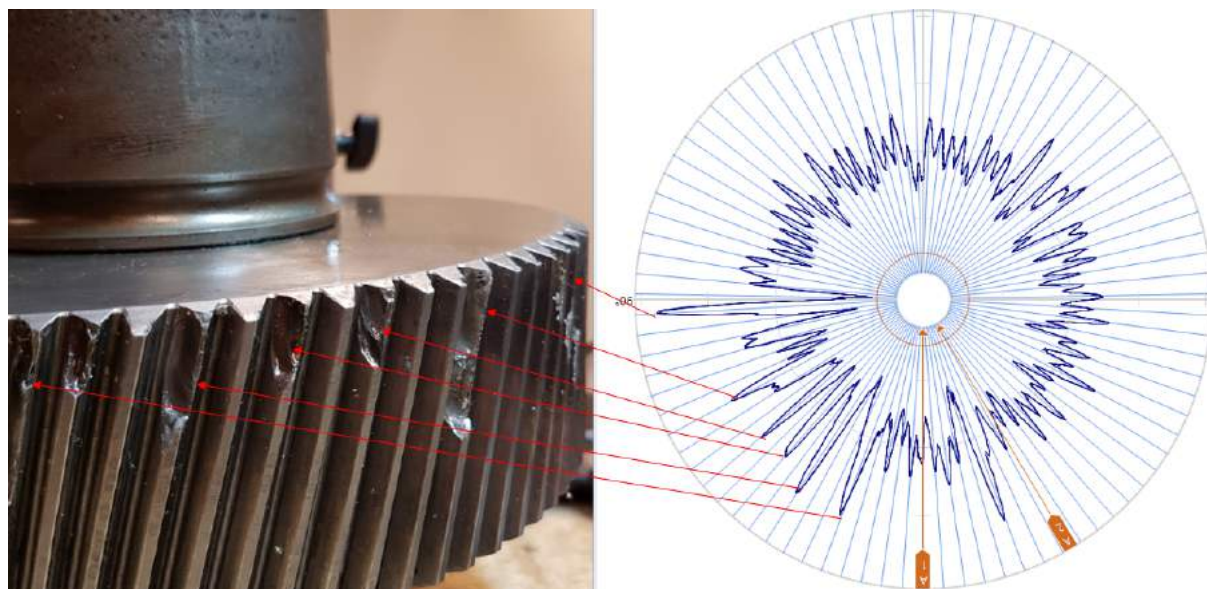
As the bearings became worn out, the gears did not mesh as designed and were therefore damaged, see Images 3 and 4 below. In Image 3, it is possible to see the gear damages of the 1st intermediate shaft shown in the circular plot.

Img 3. Damaged 1st intermediate shaft and circular plot.

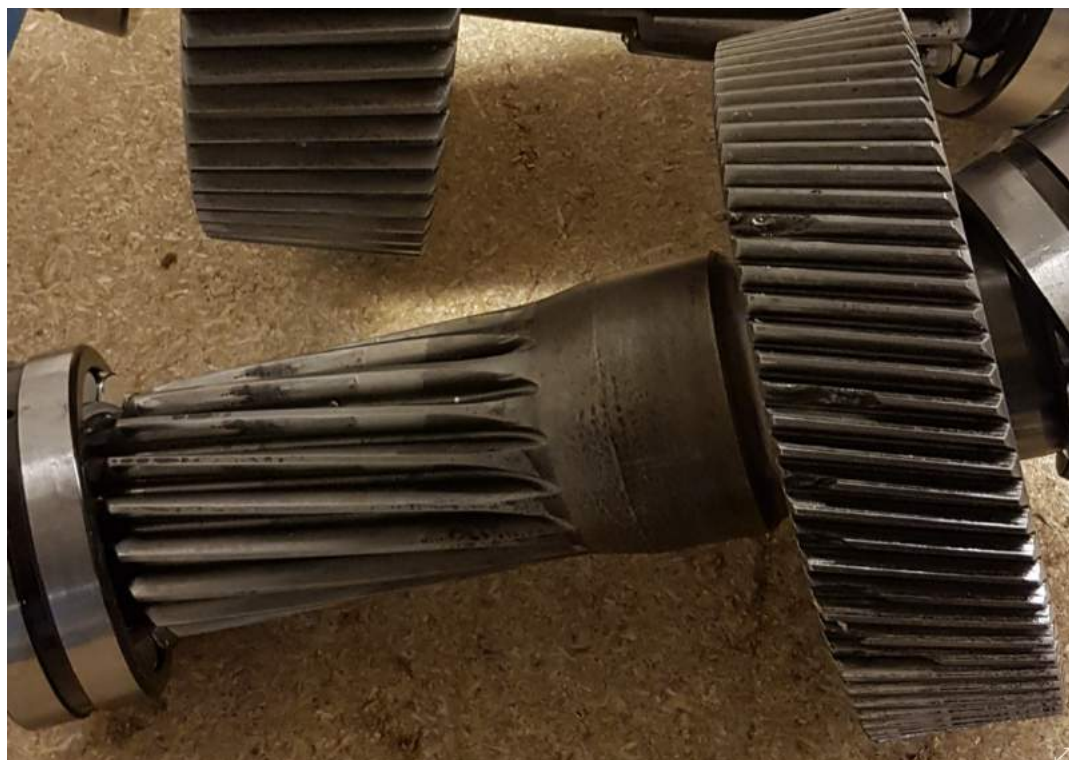
Img 4. Damaged 1st intermediate shaft.

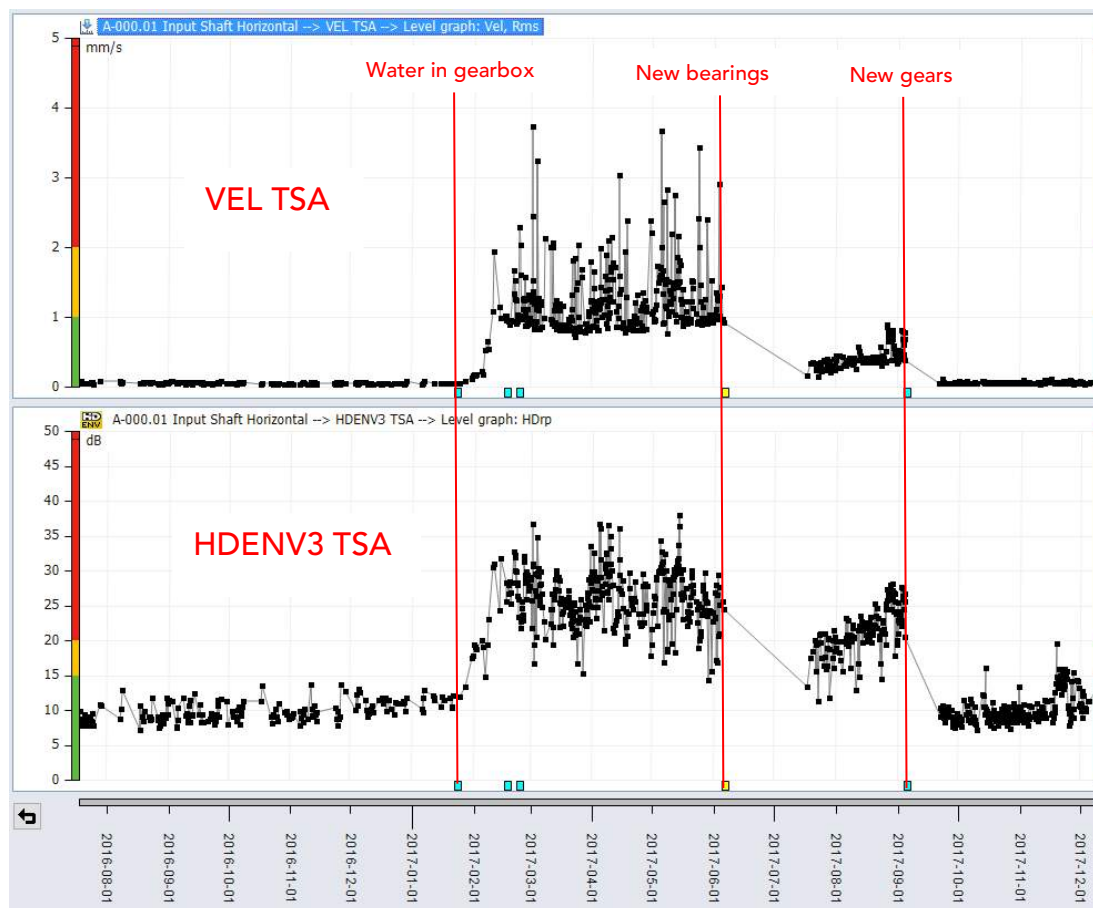
The measurements from the input shaft showed quite the same thing as those acquired from the intermediate shaft. The damaged gears are shown in Images 5 and 6.

Fig. 10 Measurements from the input shaft.

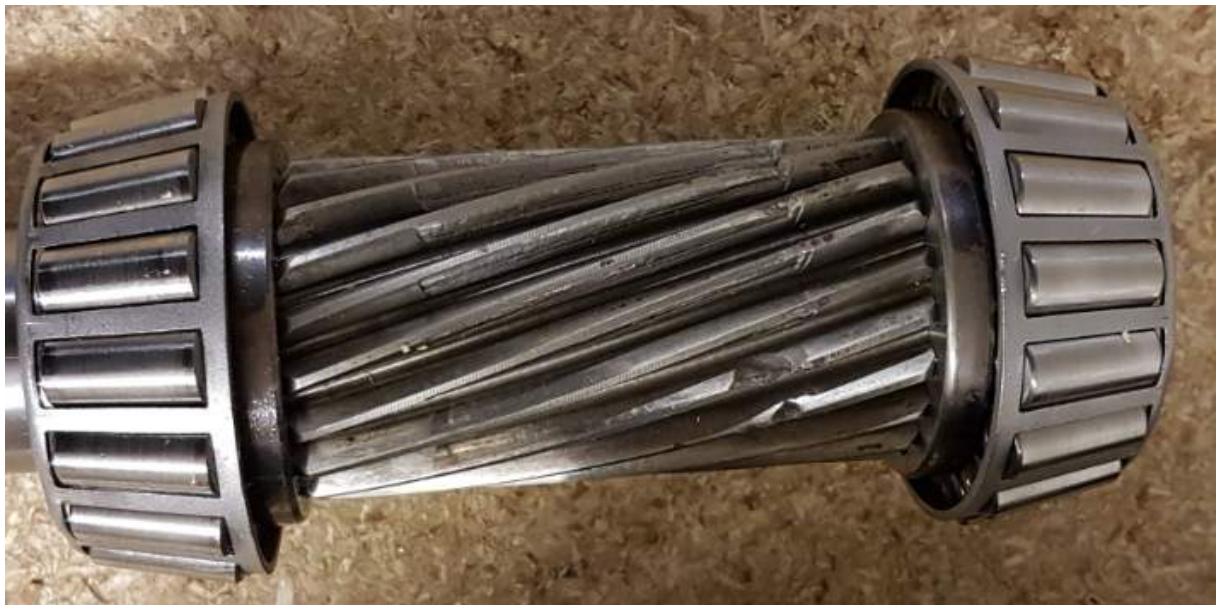
Img. 5 Damaged input shaft gear.

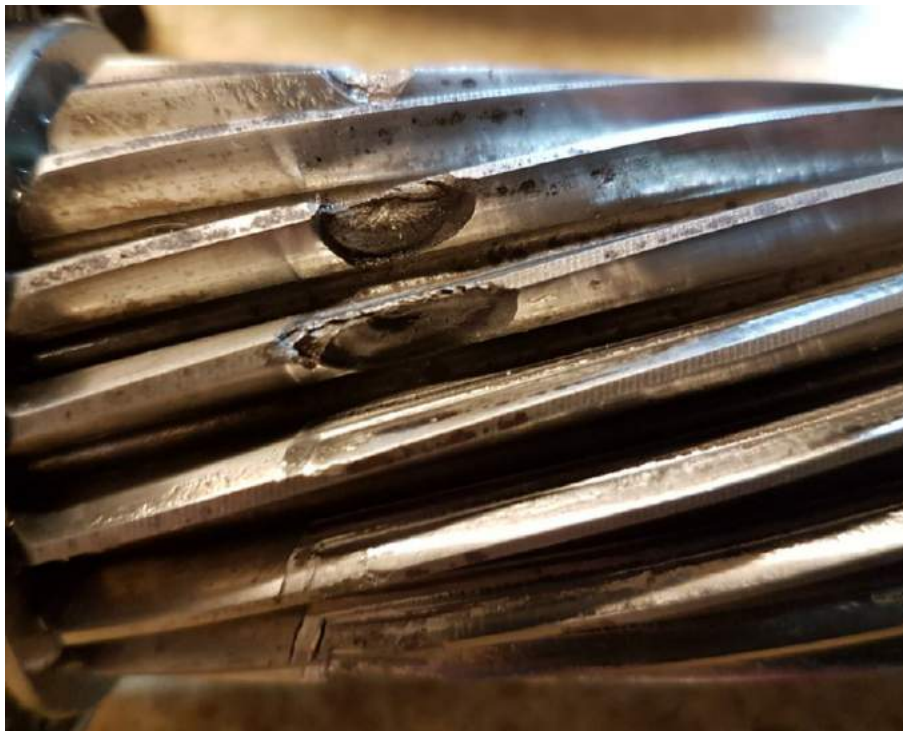
Img. 6 Damaged input shaft gear.

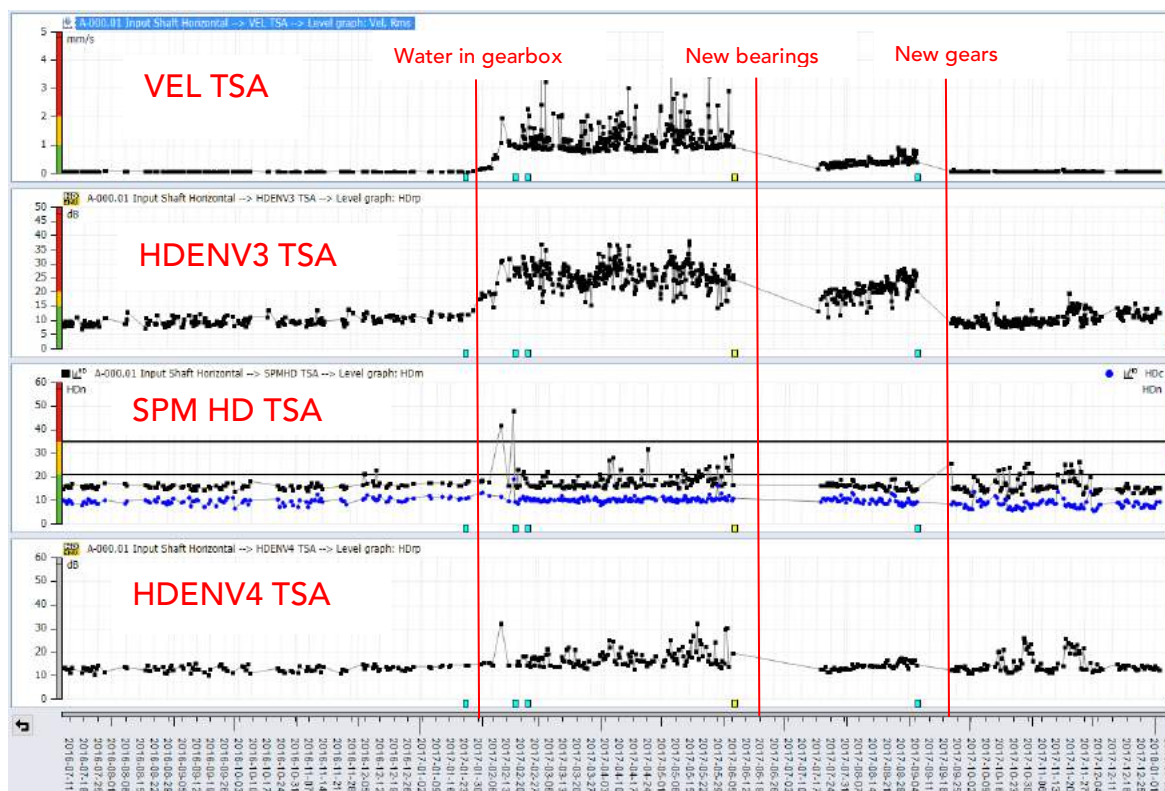
Comparing the different TSA assignments is interesting. In Figure 11 below, all TSA assignments from the input shaft are shown, and it is clear that only VEL TSA and HD ENV, Filter 3 with TSA measurement assignments react to this gear damage.

Fig. 11 Only VEL TSA and HD ENV, Filter 3 TSA indicate the gear damage.

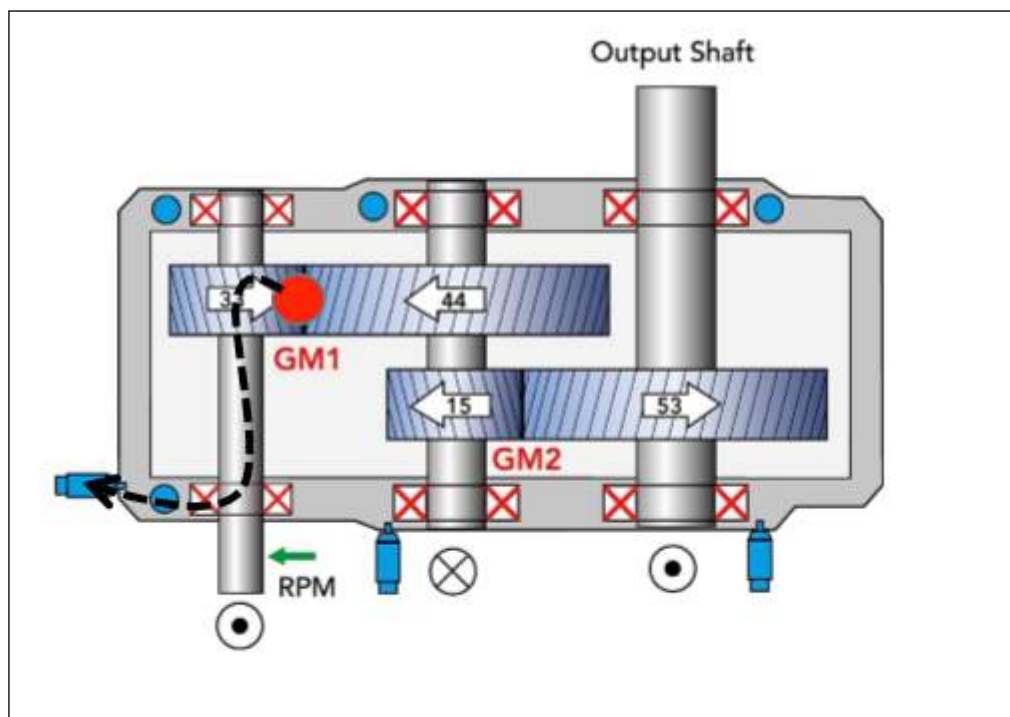
The reason for this behavior can be seen in Figure 12. The high-frequency signals – originating from the gear damage and measured with SPM HD and HD ENV, Filter 4 – are damped at each of the material interfaces in the bearings.

Fig. 12 Only VEL TSA and HD ENV, Filter 3 with TSA indicate the gear damage.
