HD Technology Case Study:

Bearing monitoring of Paper Machine K25, Vrancart SA, Romania

SPM Instrument Bulgaria EOOD

August 2017

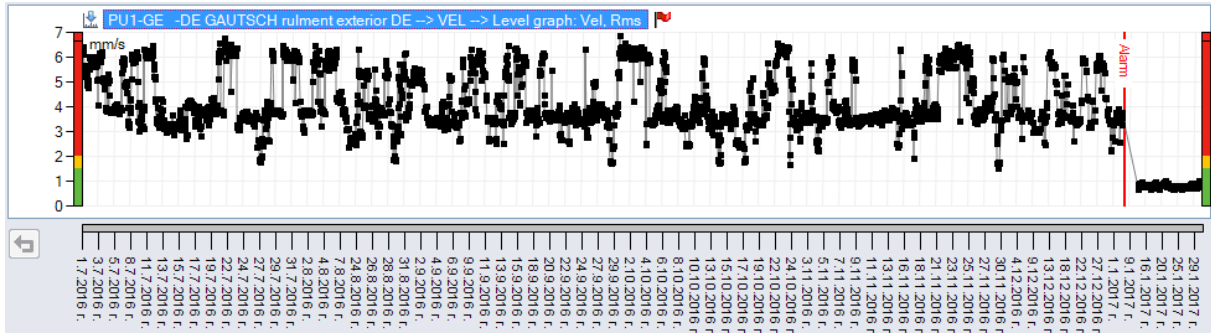
Fig 6. Velocity – VEL, trend graph, from July, 2016, to February, 2017.

The signals just above 50X (see below) are related to the plastic seals of the vacuum chamber inside the roll. When the bearing was replaced, the seals were also replaced.

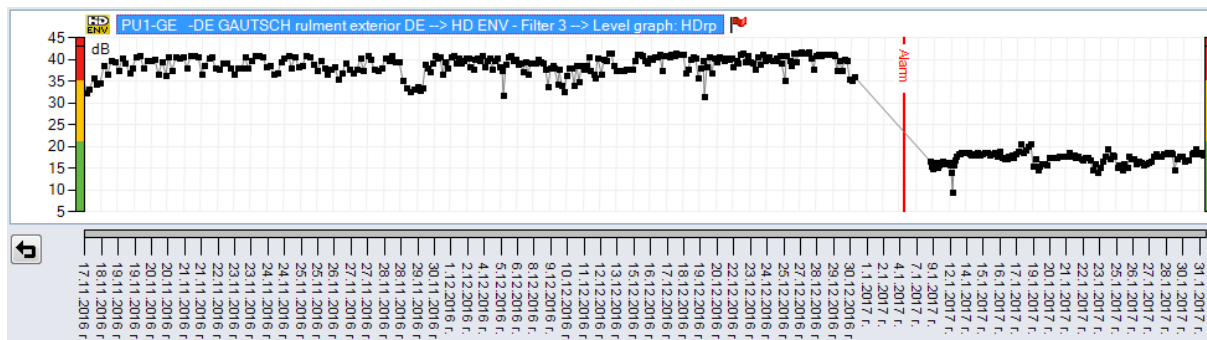
Fig 9. HD ENV - Filter 3, trend graph from November, 2016, to February, 2017.

Manual alarm levels were used for HDrp settings.

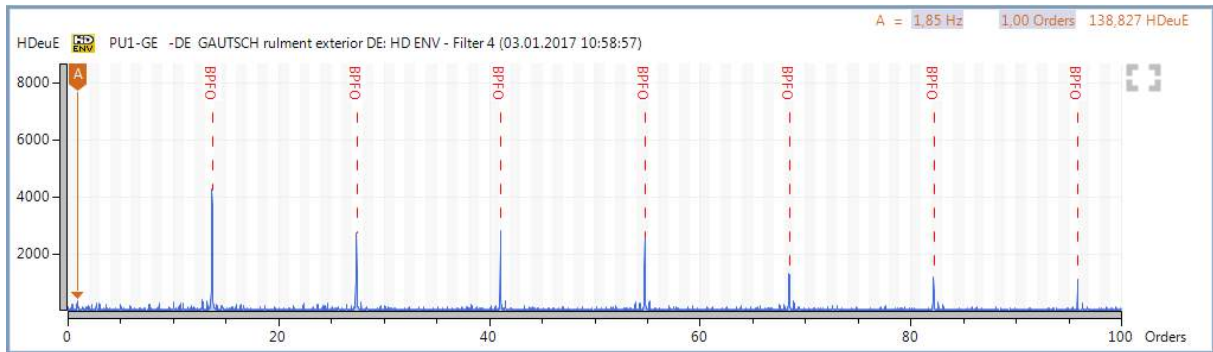
Fig 14. HD ENV - Filter 4, Spectrum.

In the time signal, fourteen clear shocks per 1 revolution can be observed. In the spectrum, there are visible harmonics matching the BPFO bearing symptom for this 23096 FAG bearing.
